**US Army Corps  
of Engineers**

**TECHNICAL REPORT REMR-COS**

**CASE HISTORIES OF CORPS BREAKWATER  
AND JETTY STRUCTURES**

**Report 6  
NORTH PACIFIC DIVISION**

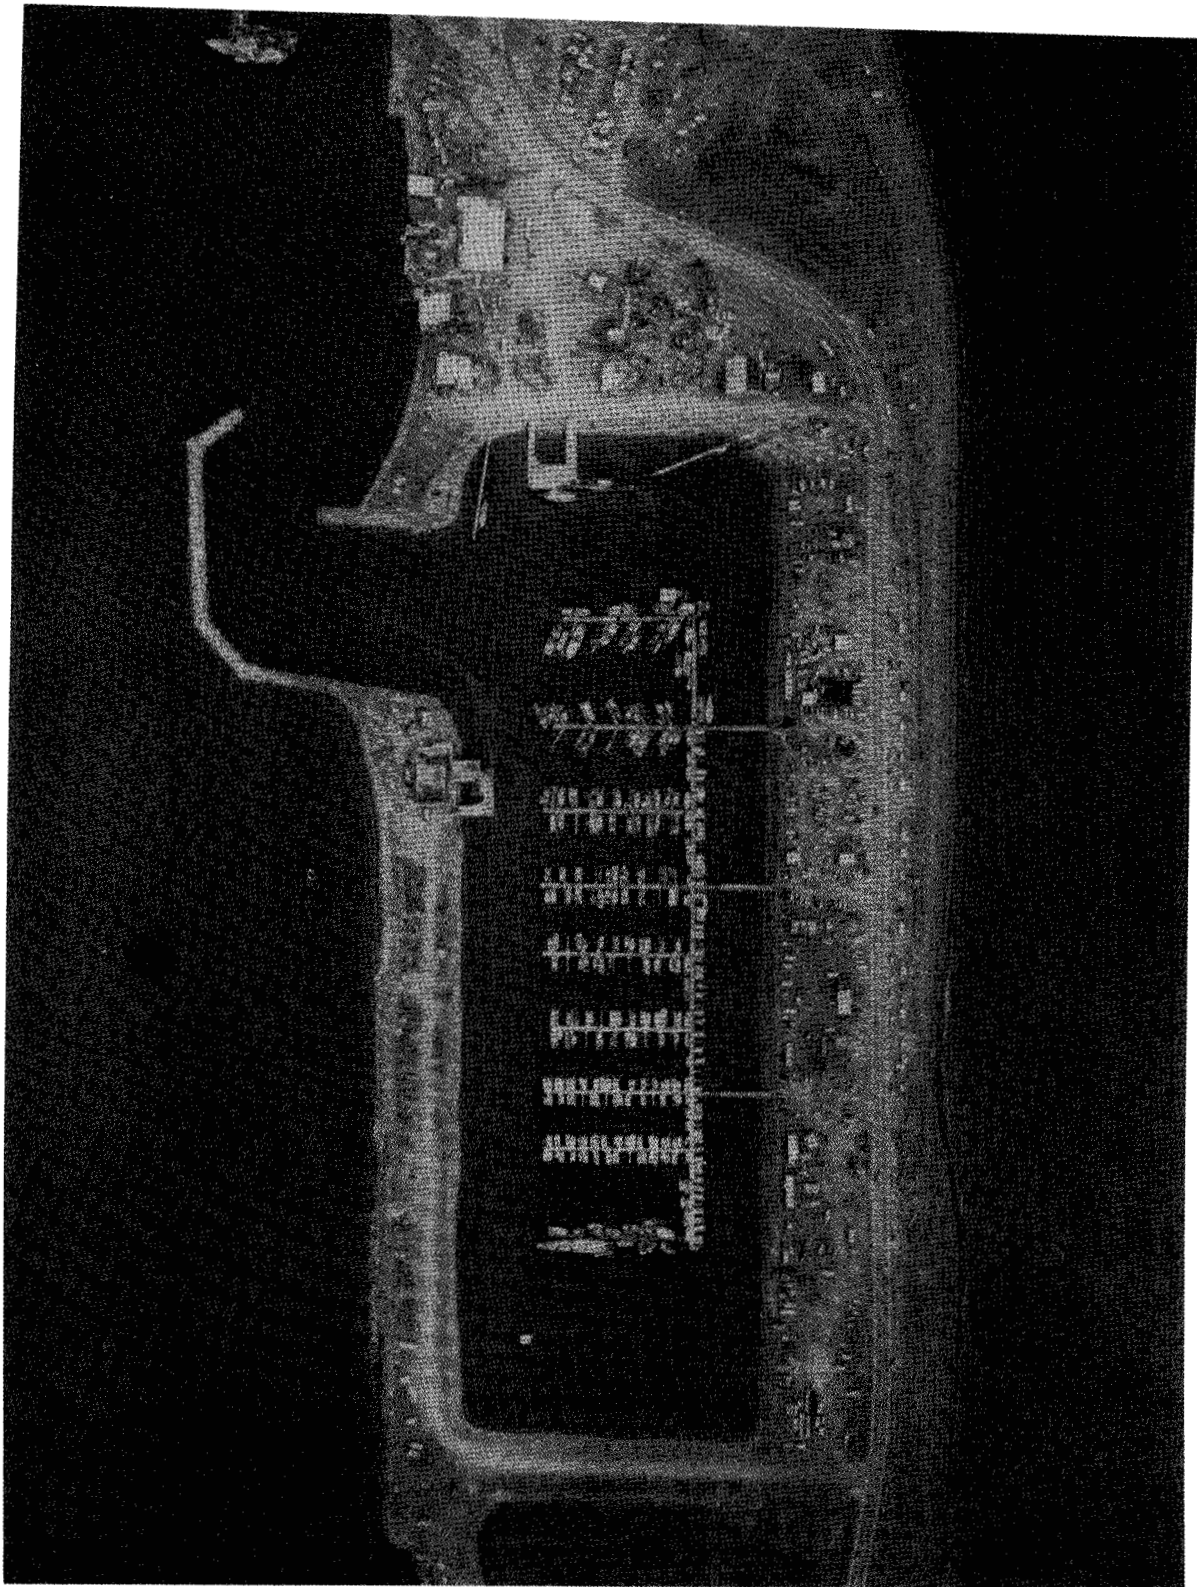
Figure 14. Aerial photograph of Homer Harbor, Alaska, 1977

| 1985 | The breakwaters are in good condition at this time. |

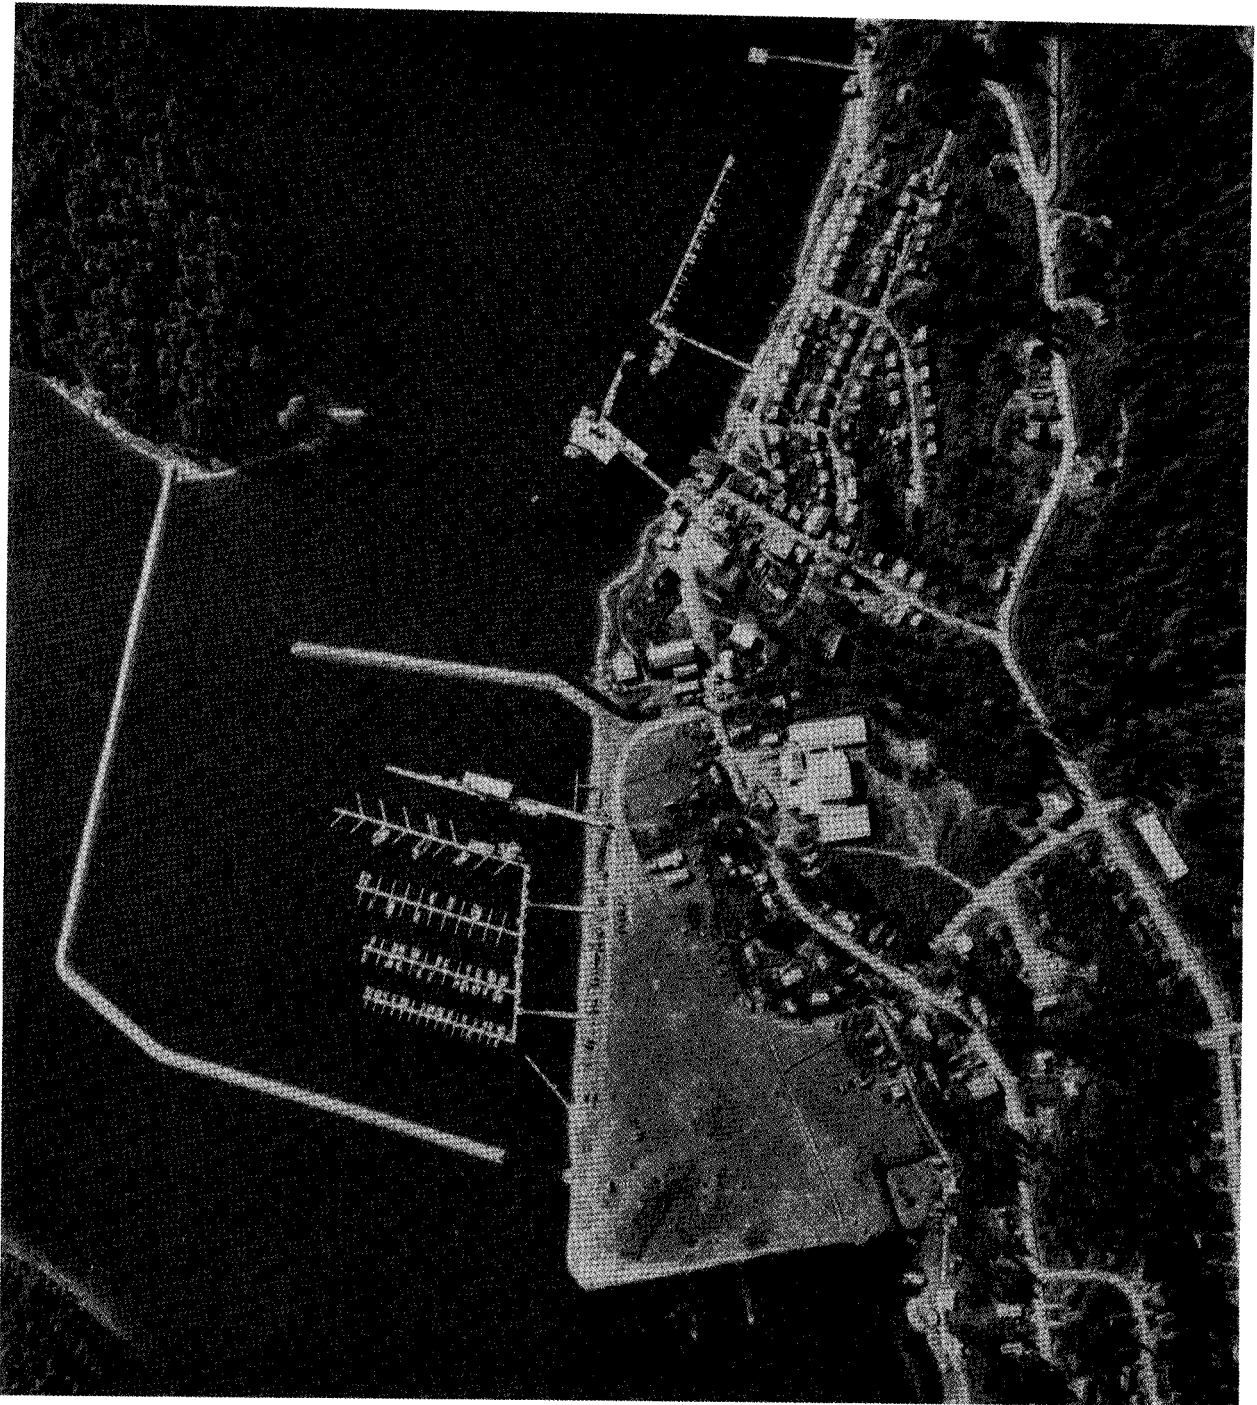
Figure 18. Aerial photograph of Hoonah Harbor, Alaska, 1984

| <u>Date(s)</u> | <u>Construction and Rehabilitation History</u> |
|---|--|
| 1985 | An aerial photograph of the harbor is presented in Figure 18. There are no reports of needed repairs or rehabilitation. |

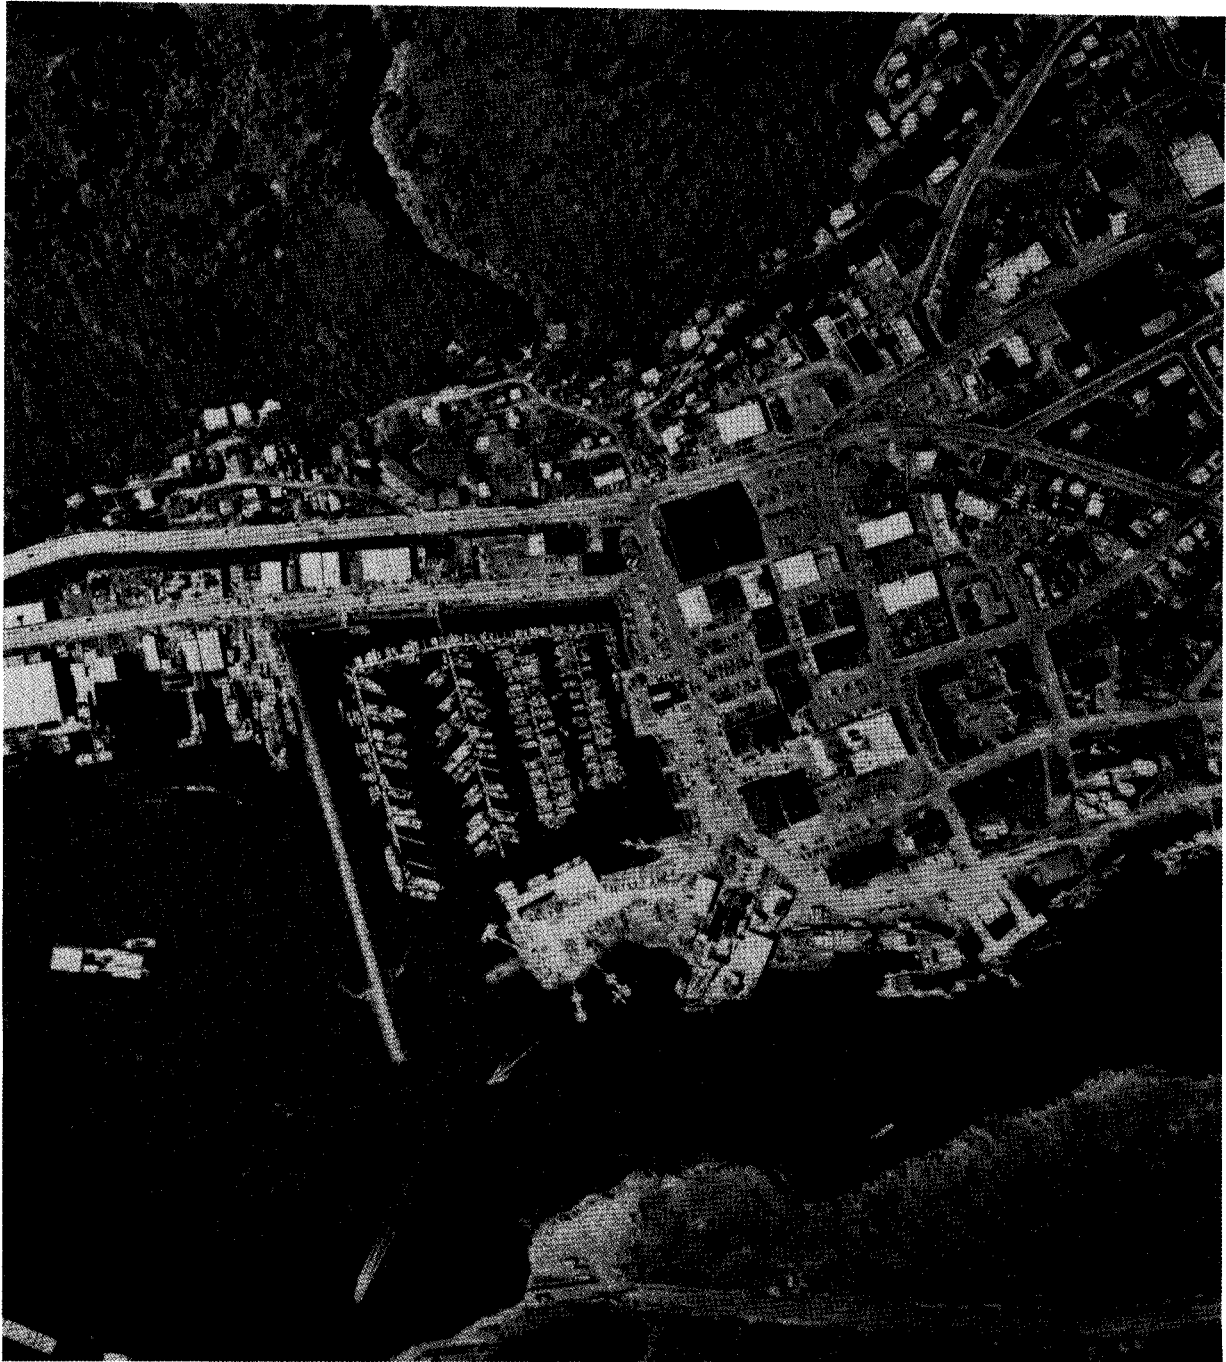
Figure 28. Aerial photograph of Kodiak Harbor, Alaska, 1985

| <u>Date(s)</u> | <u>Construction and Rehabilitation History</u> |
|---|---|
| <b>1985</b> | The harbor is illustrated in Figure <b>27</b> , and an aerial photograph of the harbor is presented in Figure <b>28</b> . There have been no reports of needed repairs or rehabilitation since <b>1973</b> . |

| <u>Date(s)</u> | <u>Construction and Rehabilitation History</u> |
|---|---|
| <b>1964</b> | The ground subsided 5 ft in an earthquake causing severe damage to the basin and breakwaters. The breakwaters were rebuilt with <b>70,000</b> tons of rock. Cross sections of the repaired breakwaters are shown in Figure 27. |
| <b>1973</b> | The tip of the southeast breakwater was repaired. |

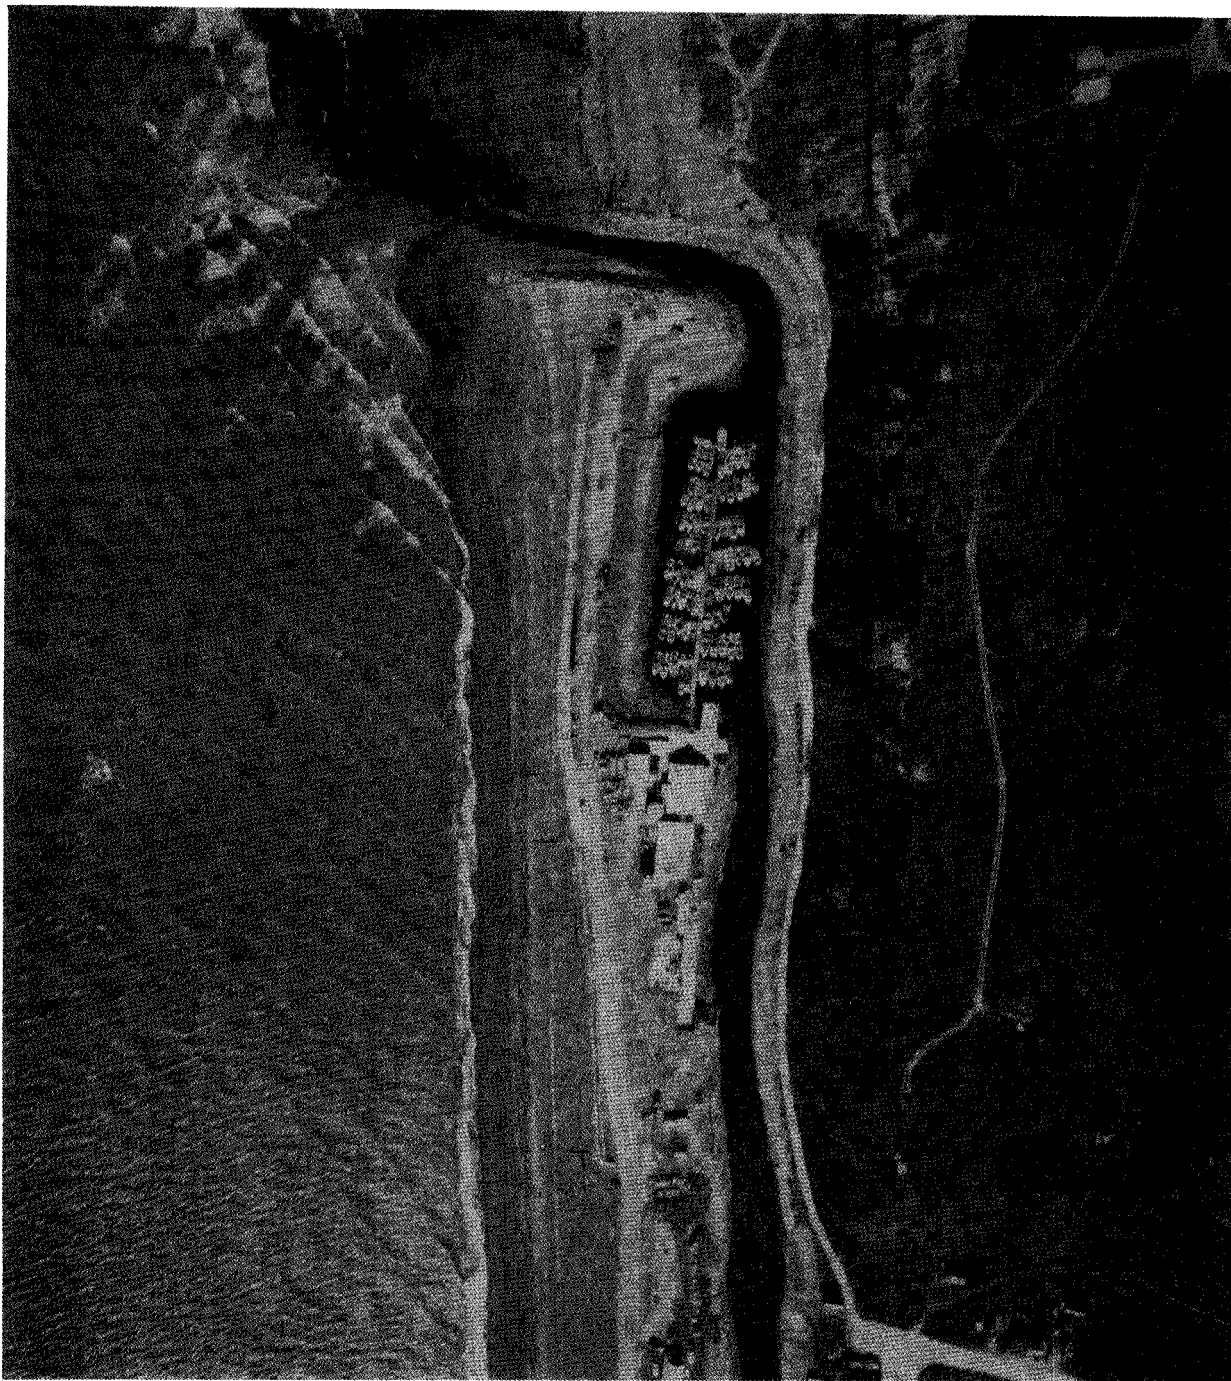
Figure 35. Aerial photograph of Ninilchik Harbor, Alaska, 1980

| <u>Date( s)</u> | <u>Construction and Rehabilitation History</u> |
|---|--|
| 1985 | The harbor is illustrated in Figure 34, and an aerial photograph of the harbor is presented in Figure 35. The harbor has required annual maintenance dredging and repairs since its construction. |

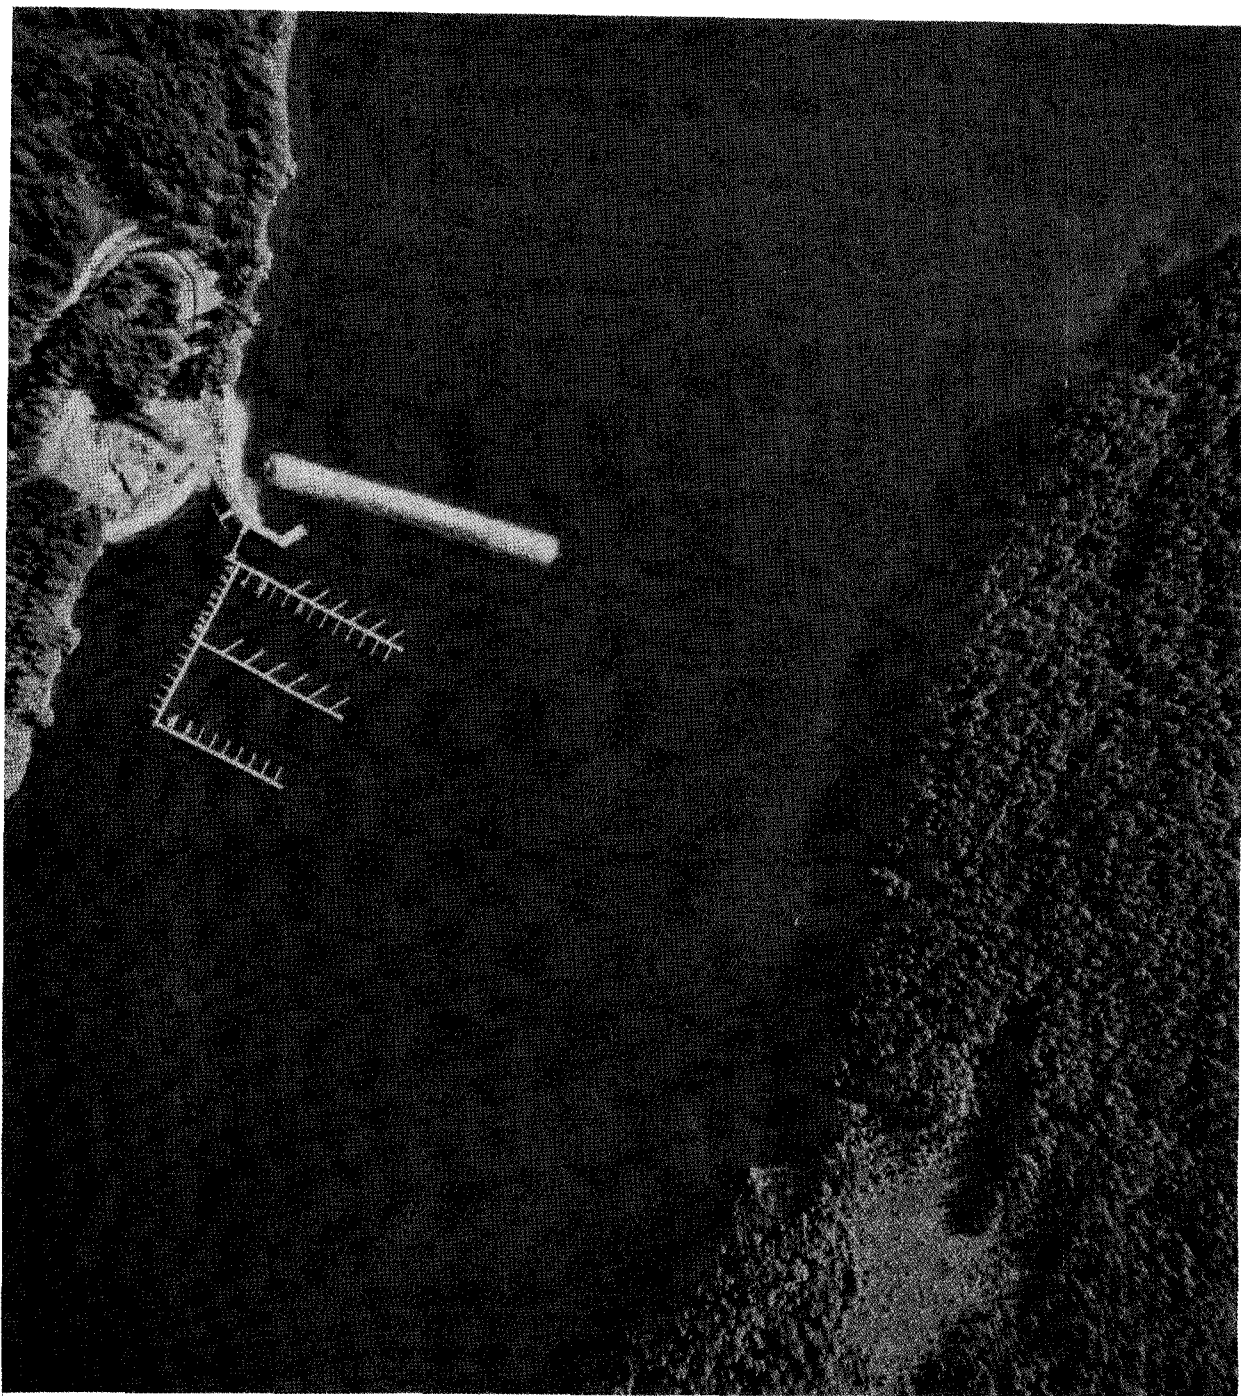
Figure 41. Aerial photograph of Port Lions Harbor, Alaska, 1984

| <u>Date( s)</u> | <u>Construction and Rehabilitation History</u> |
|---|--|
| 1985 | The harbor is illustrated in Figure 40, and an aerial photograph of the harbor is presented in Figure 41. There have been no reports of needed repairs or rehabilitation since 1983. |

| <u>Date( s)</u> | <u>Construction and Rehabilitation History</u> |
|---|--|
| 1983 | The main breakwater was rebuilt and lengthened to 725 ft, and an entrance channel was dredged. The breakwater and the extension were rebuilt with a core of 5- to 50-lb stone, a layer of secondary armor rock and a layer of Class "A" armor rock on the crest and seaward sides, and Class "B" armor rock on the basin side. The armor rock in the secondary layer included 95 percent over 50 lb and 30 to 70 percent over 600 lb. The Class "B" armor rock was over 400 lb, with 85 percent over 1,000 lb. The Class "A" armor rock was 98 percent over 3,000 lb and 75 percent over 4,000 lb. |

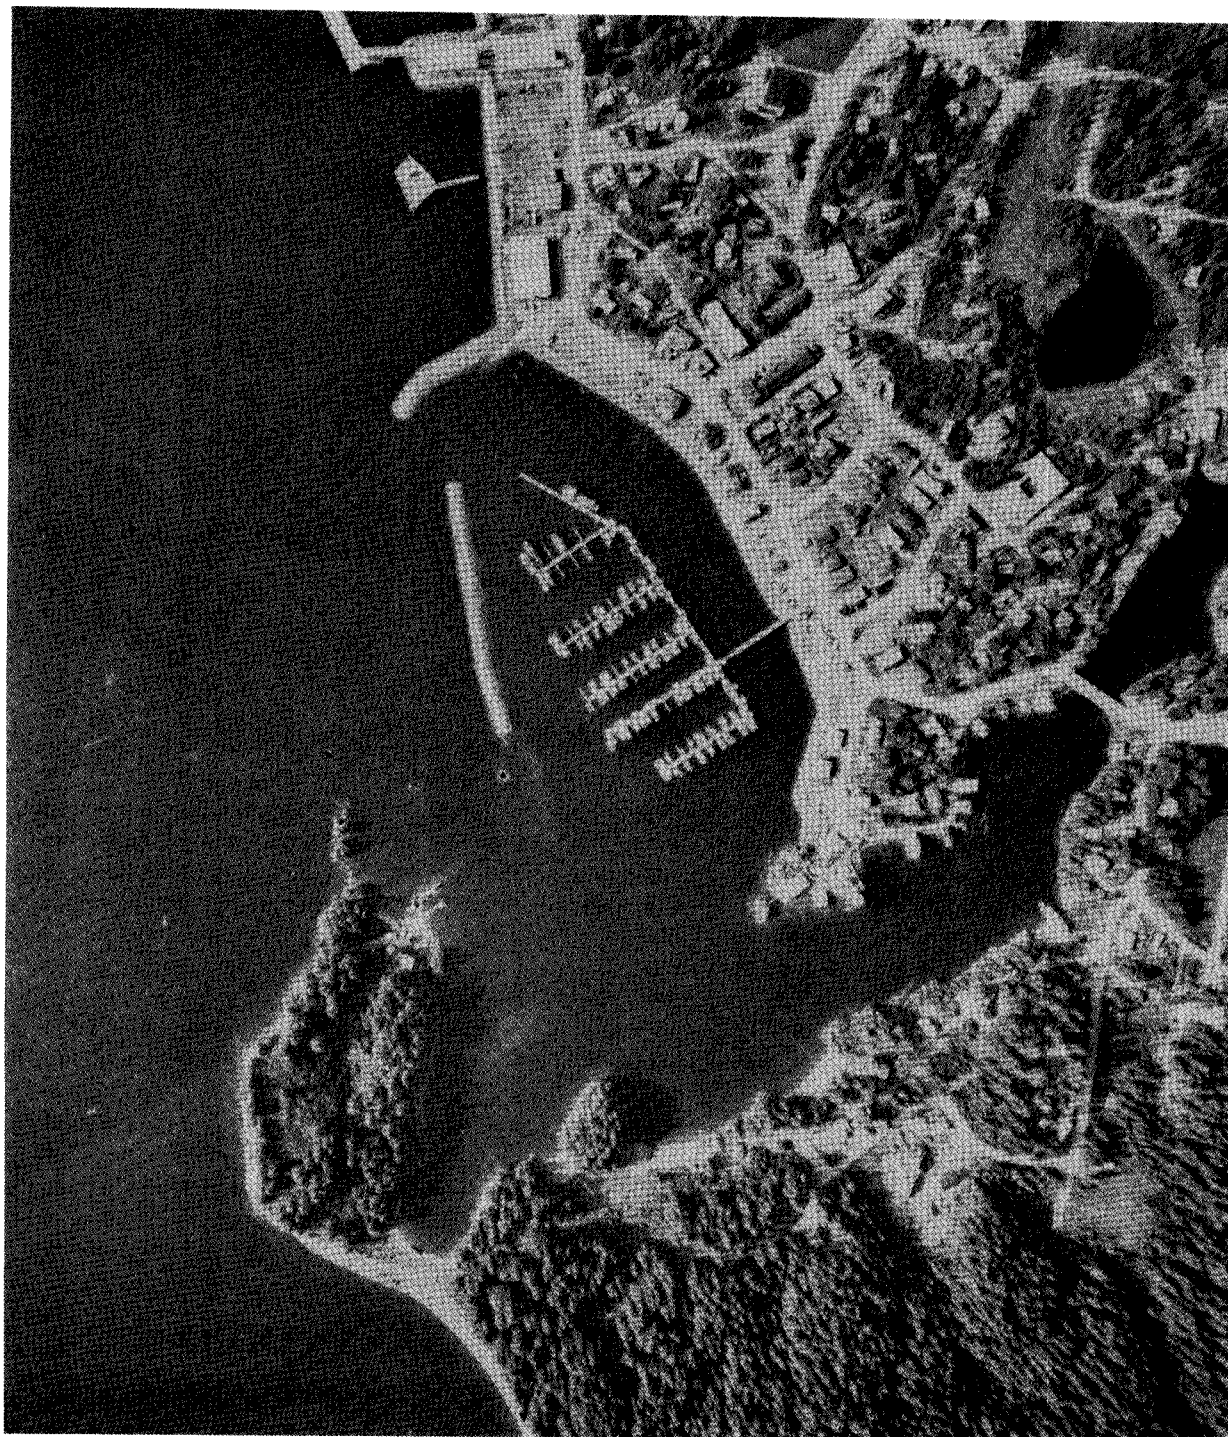
Figure 43. Aerial photograph of Seldovia Harbor, Alaska, 1984

| Date(s) | Construction and Rehabilitation History |
|---|---|
| 1985 | The harbor is illustrated in Figure 42, and an aerial photograph of the harbor is presented in Figure 43. There have been no reports of needed repairs or rehabilitation since 1964. |

| Date(s) | Construction and Rehabilitation History |
|---|---|
| 1964 | The basin subsided 3.8 ft in an earthquake. The breakwaters were repaired with a 7.5-ft-thick layer of rock on the basin side and a 4-ft-thick layer of armor rock on the crest, raising the crest elevations 0.2 ft over the original design heights, and widening the crests to 8 ft. The repair work required a total of 26,877 tons of stone. Cross sections of the rebuilt breakwaters are shown in Figure 42. |

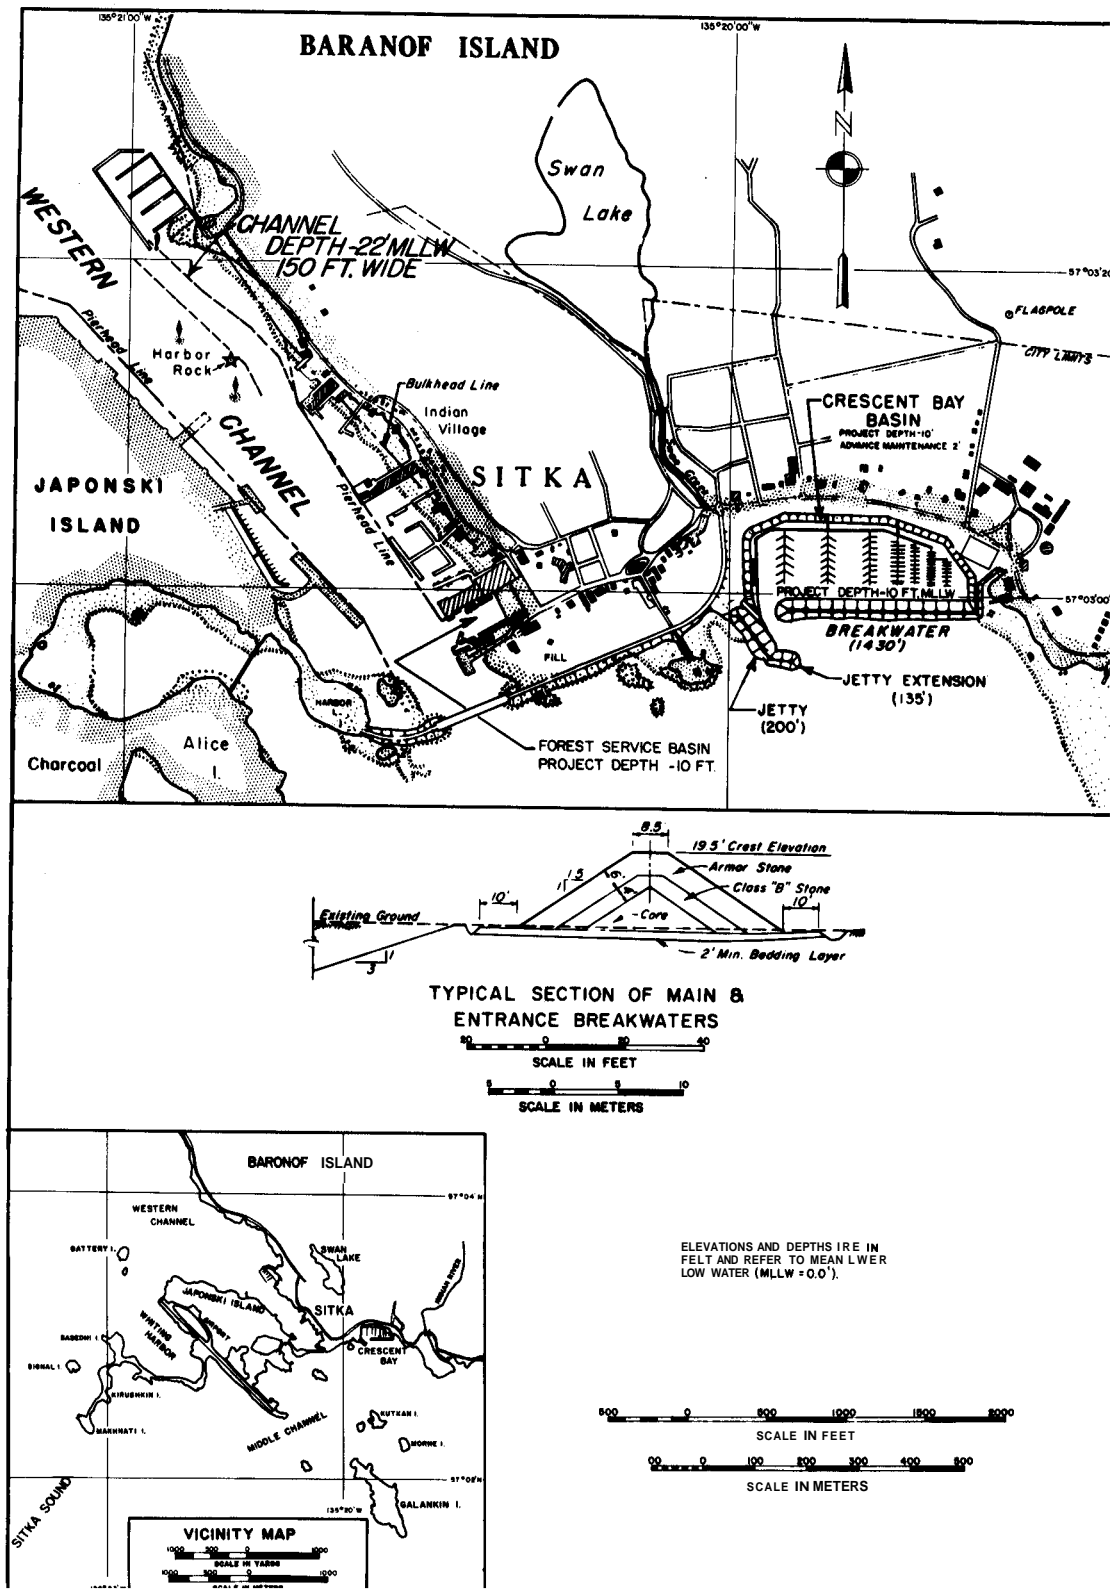
Figure 46. Site layout of Sitka Harbor, Alaska (revised 1981)

| Date(s) | Construction and Rehabilitation History |
|---|---|
| 1985 | The harbor is illustrated in Figure 46, and an aerial photograph is presented in Figure 47. There are no reports of needed repairs or rehabilitation. |

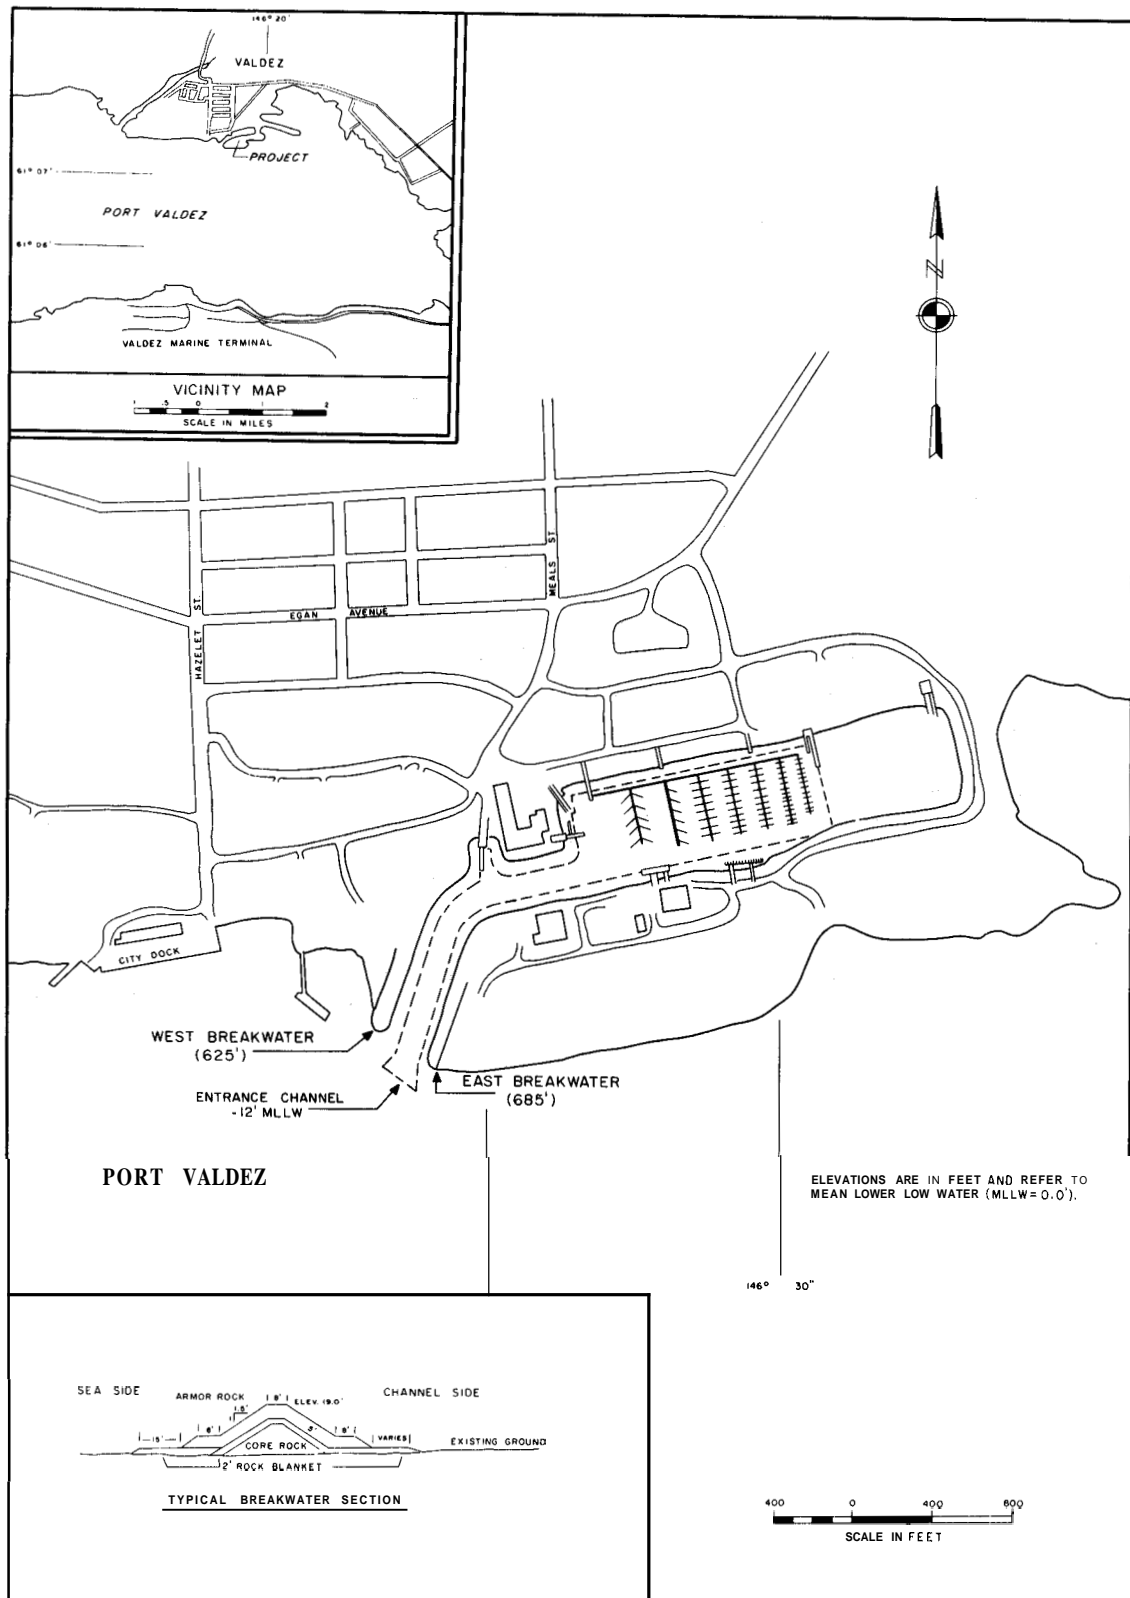
Figure 48. site layout of Valdez Harbor, Alaska, 1985

| <u>Date(s)</u> | <u>Construction and Rehabilitation History</u> |
|---|--|
| 1985 | The harbor is illustrated in Figure 48, and an aerial photograph of the harbor is presented in Figure 49. The basin was expanded by local interests to 19 acres. There are no reports of needed repairs or rehabilitation at the new harbor. |

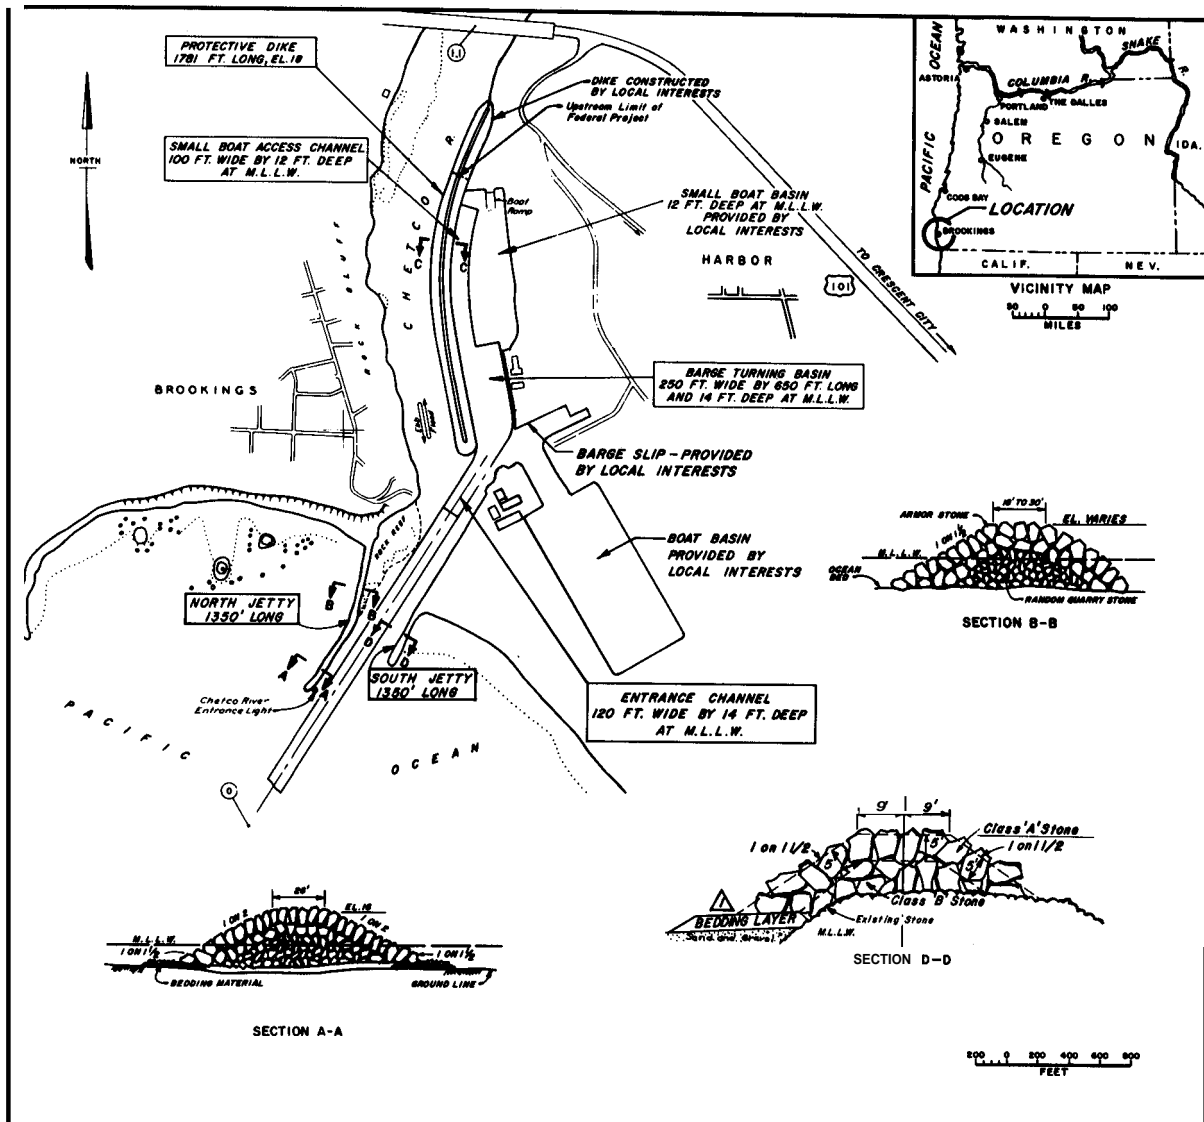
Figure 52. Site layout of Chetco River, Oregon (revised 1979)

| Date( s) | Construction and Rehabilitation History |
|---|---|
| 1985 | The harbor and jetty cross sections are shown in Figure 52. There have been no reports of repairs or rehabilitation since 1970. |

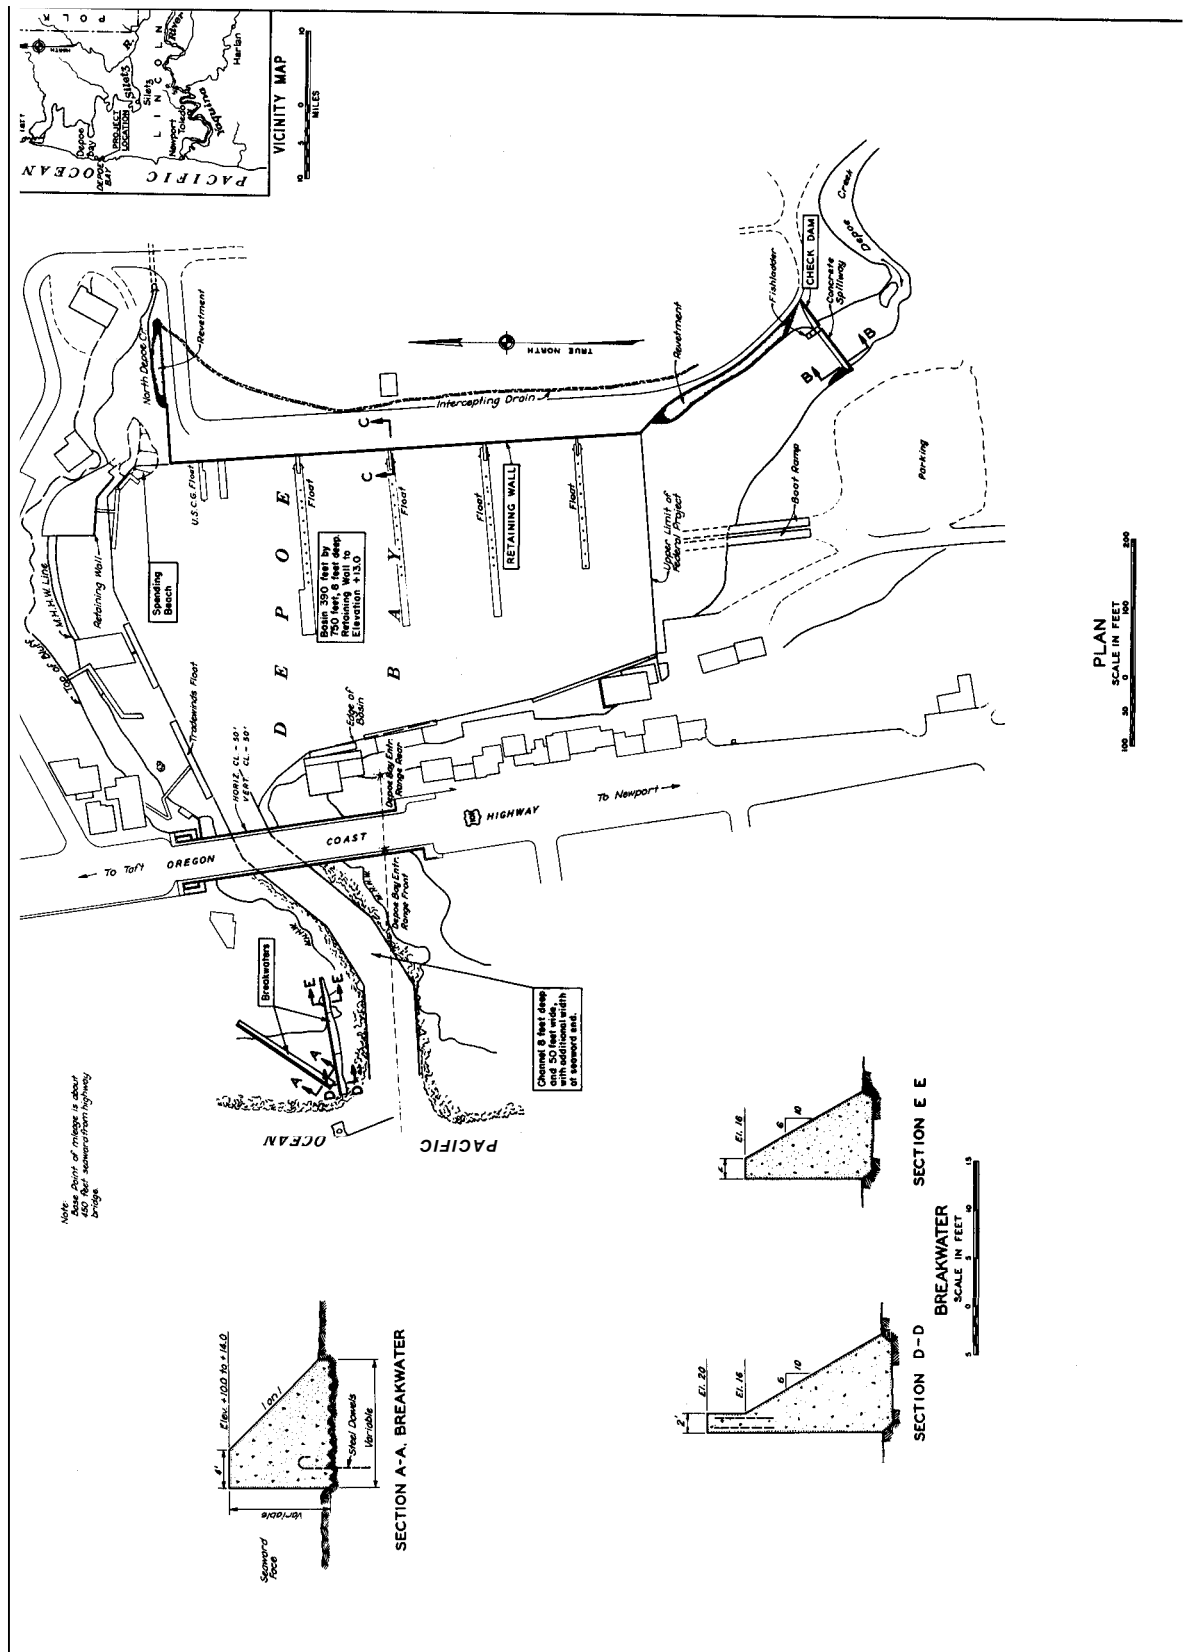
| Date(s) | Construction and Rehabilitation History |
|---|---|
| 1985 | The harbor and cross sections of the jetties and breakwater are illustrated in Figure 54. The south jetty is in good condition, but the outer 200 ft of the north jetty is in a deteriorated condition and has severe scour. The breakwater is in good condition. |

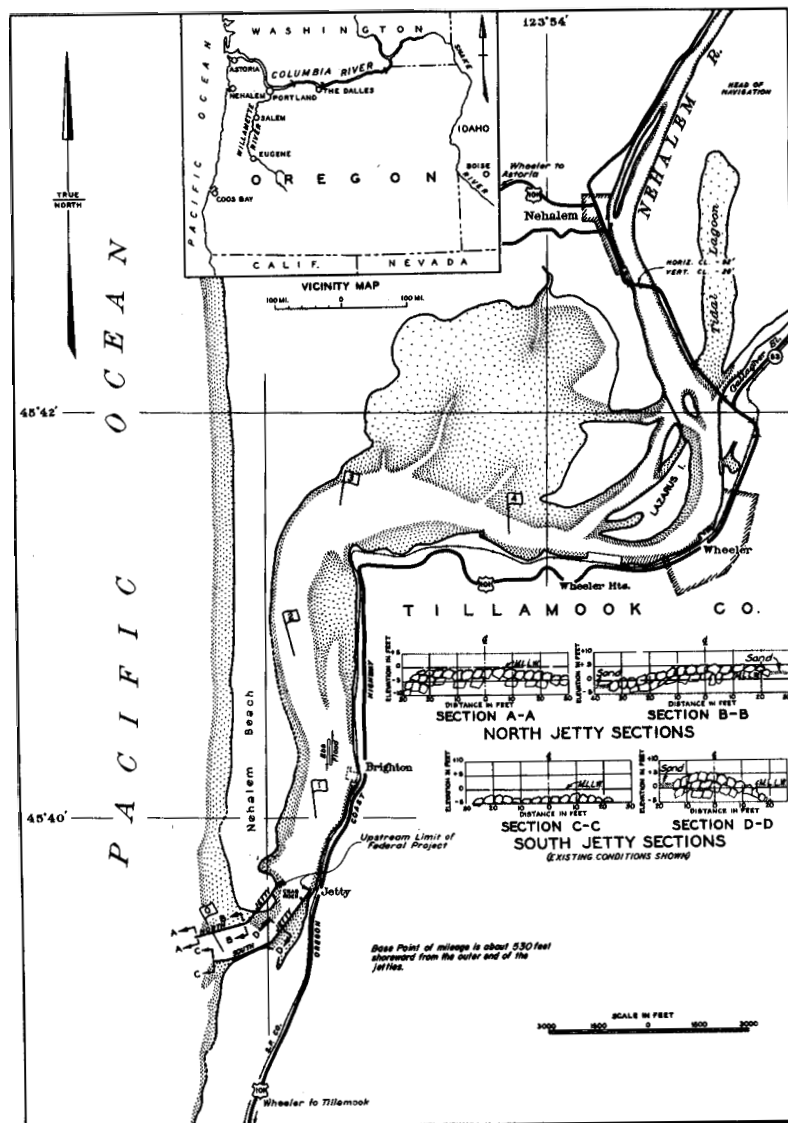
Figure 57. Site layout of Nehalem Bay, Oregon (revised 1979)

| Date(s) | Construction and Rehabilitation History |
|---|--|
| 1985 | The harbor and cross sections of the jetties are illustrated in Figure 57. The jetties are in good condition at this time. |

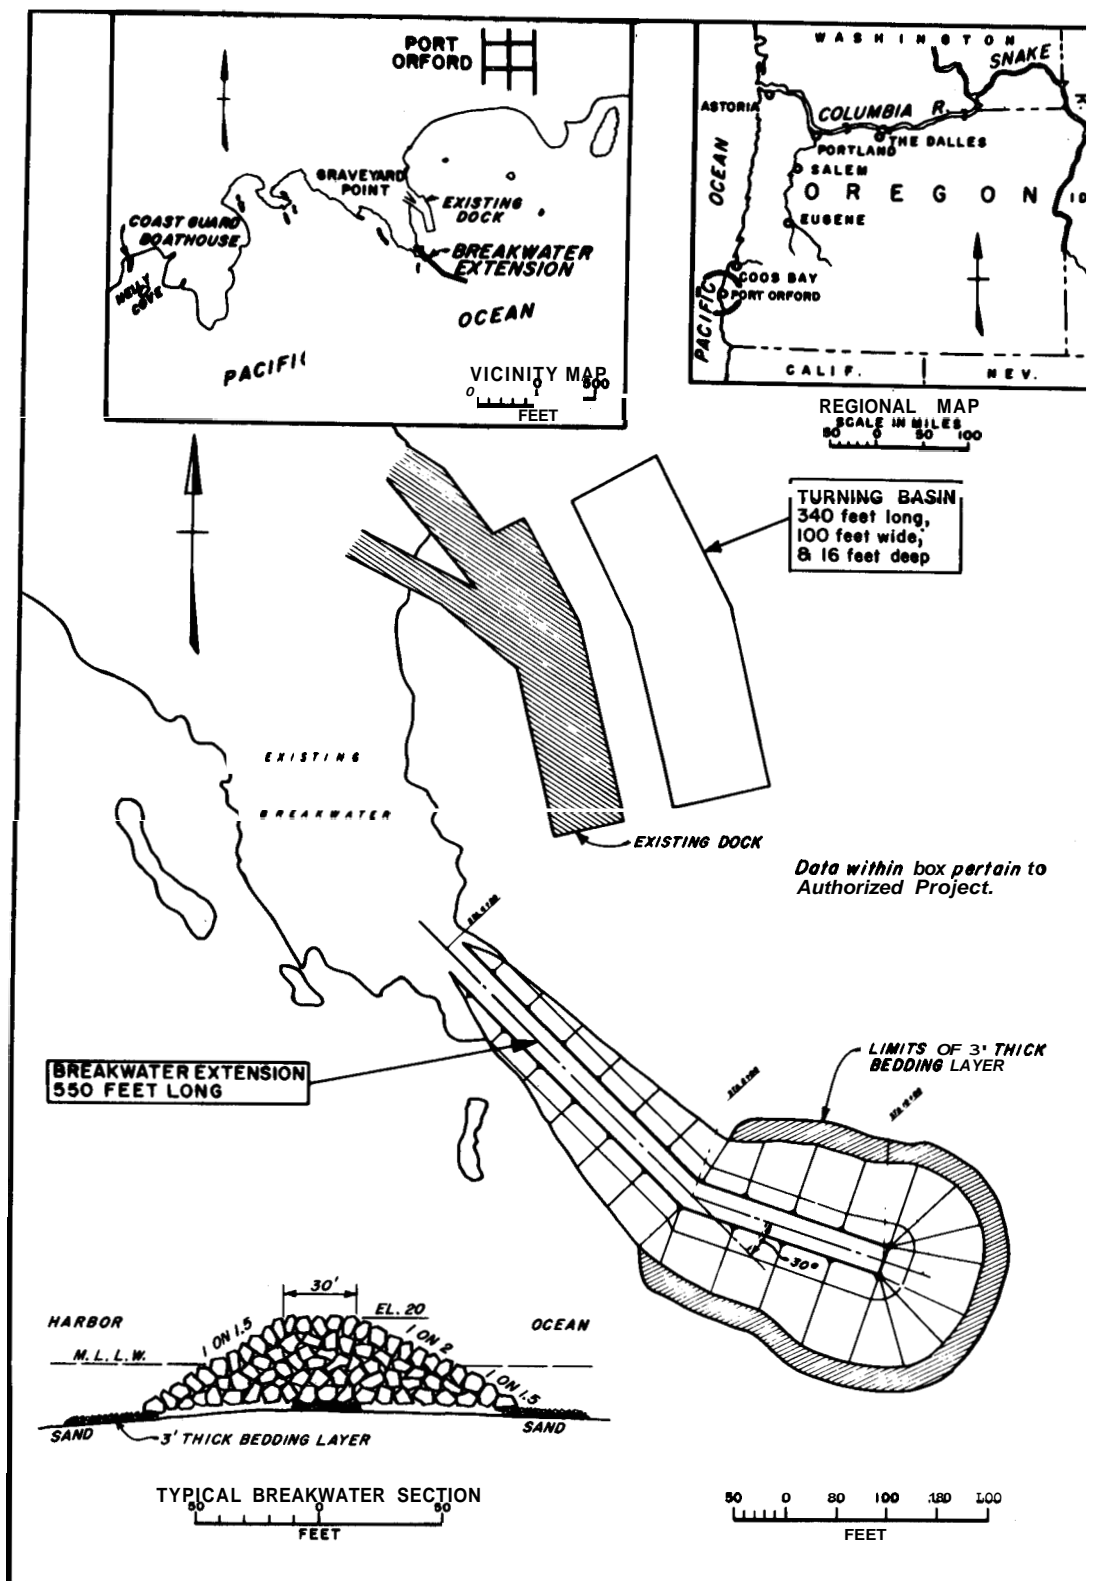
Figure 58. Site layout of Port Orford, Oregon (revised 1971)

| Date( s) | Construction and Rehabilitation History |
|---|--|
| 1985 | The harbor and cross section of the breakwater are illustrated in Figure 58. No repairs or rehabilitation are reported. |

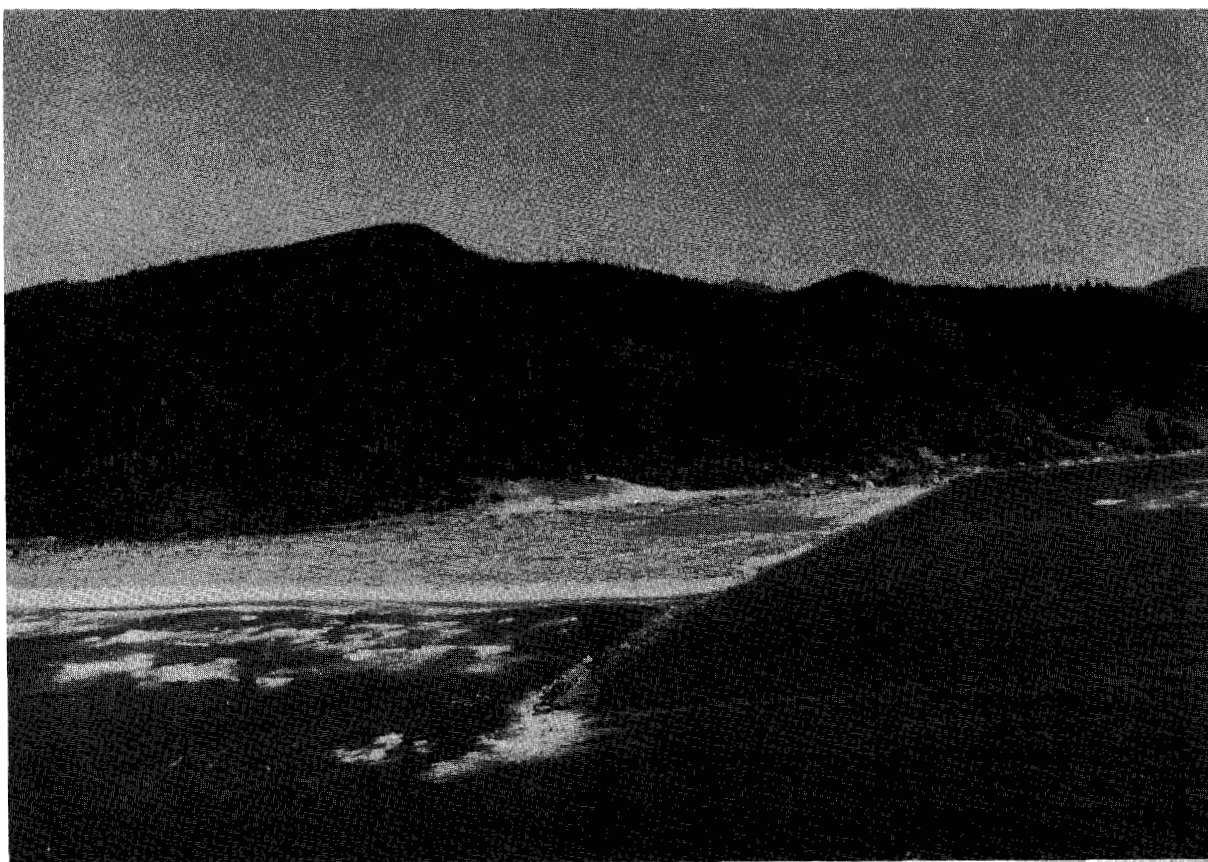
Figure 62. Aerial photograph of north jetty, Tillamook Bay, Oregon, 1955

| <u>Date(s)</u> | <u>Construction and Rehabilitation History</u> |
|---|--|
| 1955 | Repairs were made to the north jetty near the shore end. Also, a breach at the beachline of the north jetty that had been cut to bring a beached vessel through the jetty was repaired. Repair work used 5,535 tons of rock. A 1955 aerial photograph of the north jetty is given in Figure 62. |
